CORNER RECORDDocument Number CR 9257City of SAN LEANDROCounty of ALAMEDA, CaliforniaBrief Legal Description SAN LEANDRO BLVD. AND WEST ESTUDILLO AVE.

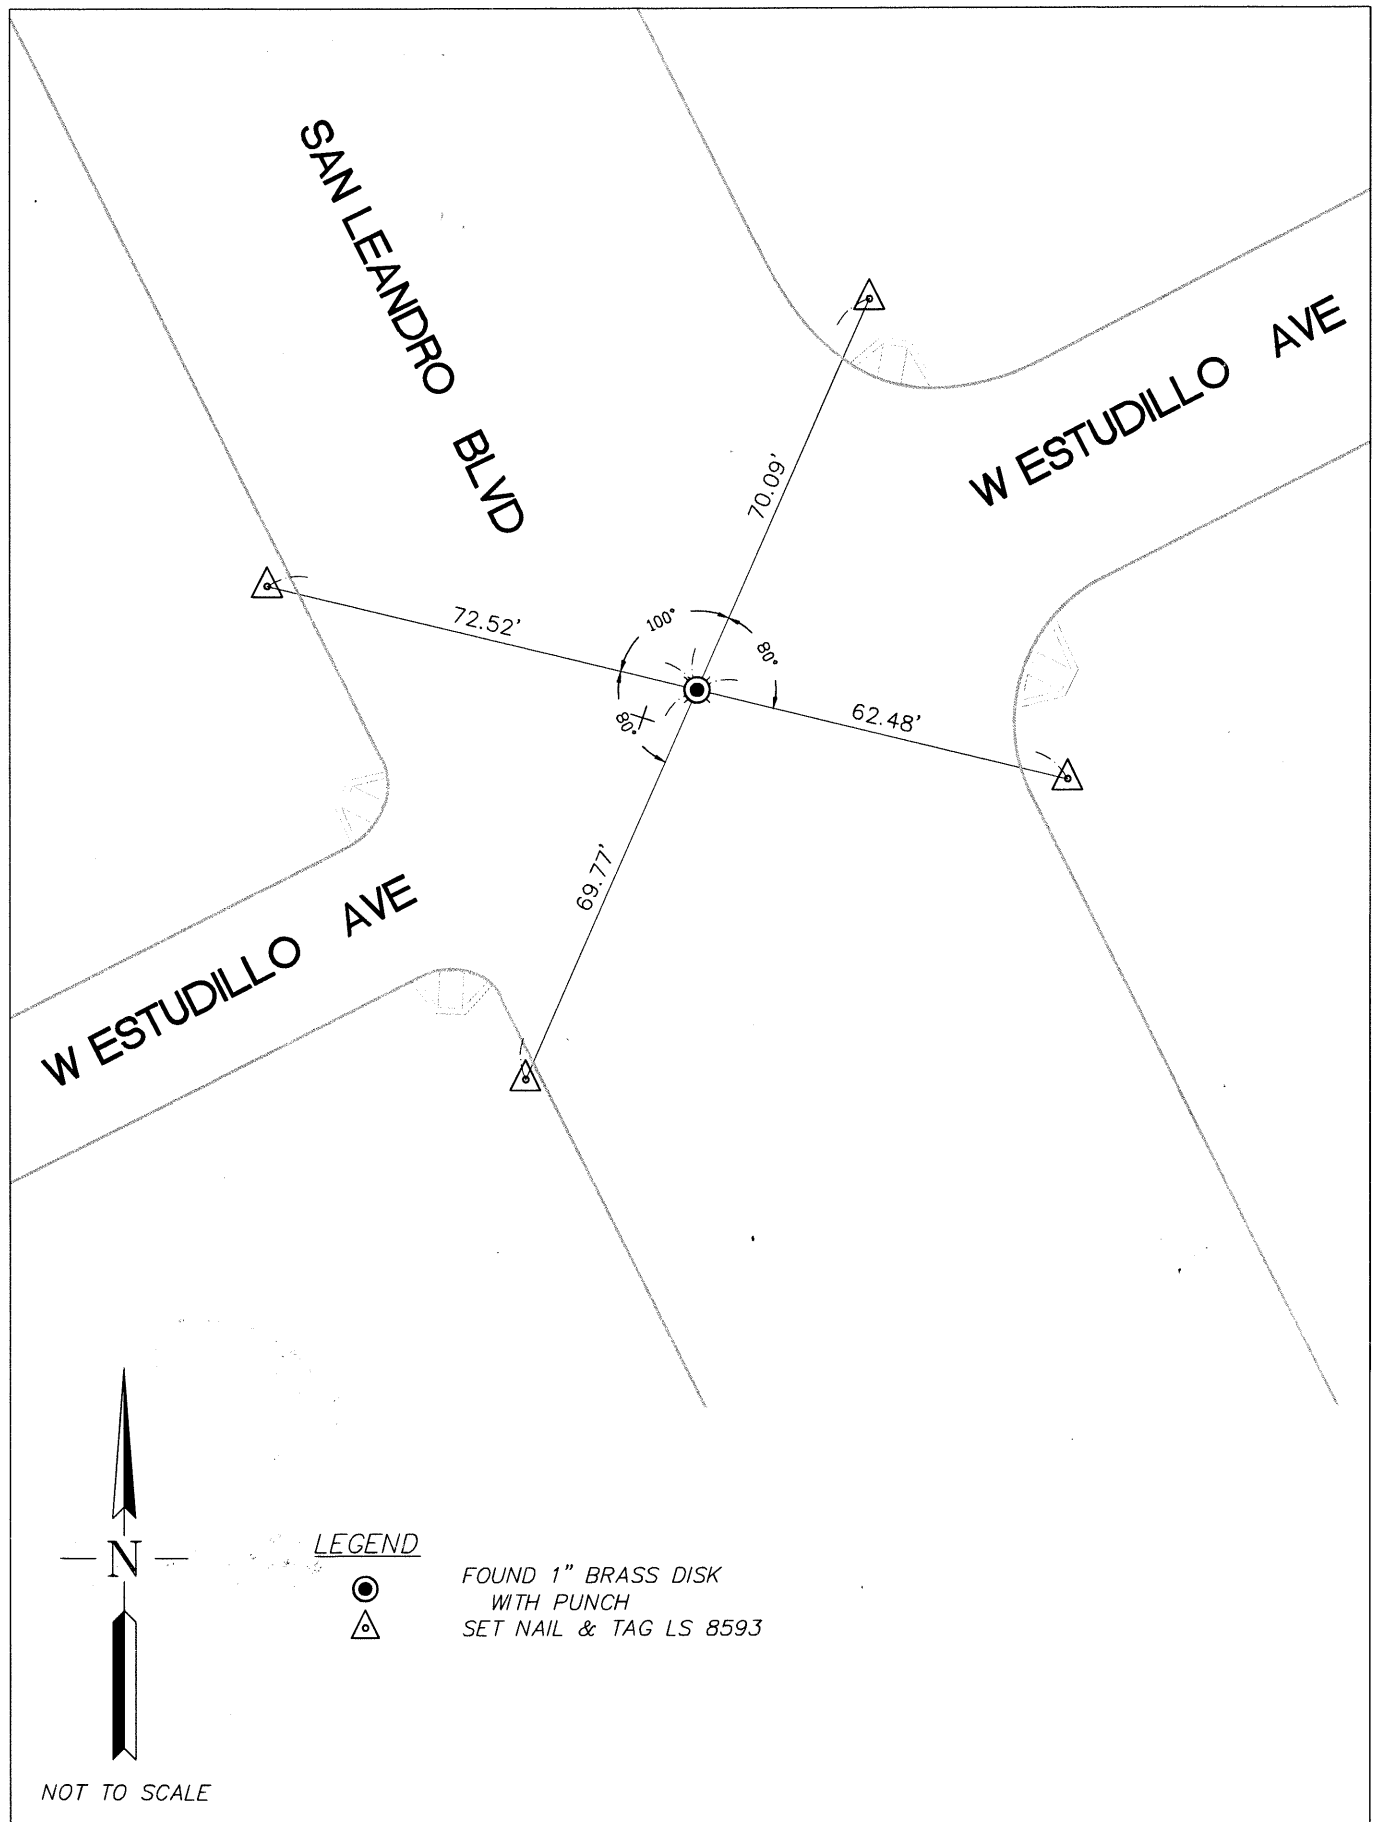
SET NAIL AND TAG, STAMPED LS 8593 AS REFERENCE POINTS TO BE USED TO RESET MONUMENT SHOULD IT
BE DISTURBED DURING CONSTRUCTION ACTIVITIES.
SEE SHEET 2 FOR GRAPHIC
SURVEYOR'S STATEMENT
